DEPARTMENT OF TRANSPORTATION

Contract #: 04-0120F4Cty: SF/ALA Rte: 80 PM: 13.2/13.9File #: 99.28**WELDING INSPECTION REPORT****Resident Engineer:**Siegenthaler, Peter**Address:** 333 Burma Road**City:** Oakland, CA 94607**Report No:** WIR-025724**Date Inspected:** 27-Jun-2011**Project Name:** SAS Superstructure**OSM Arrival Time:** 1500**Prime Contractor:** American Bridge/Fluor Enterprises, a JV**OSM Departure Time:** 300**Contractor:** Zhenhua Port Machinery Company, Ltd (ZPMC) Chanxing Island**Location:** Shanghai, China

WELDING INSPECTION REPORT

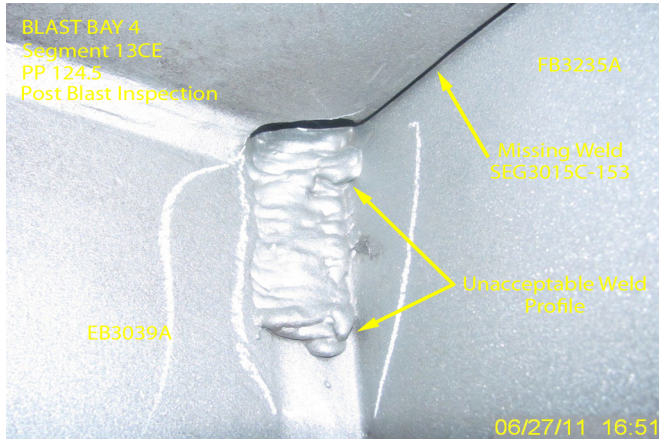
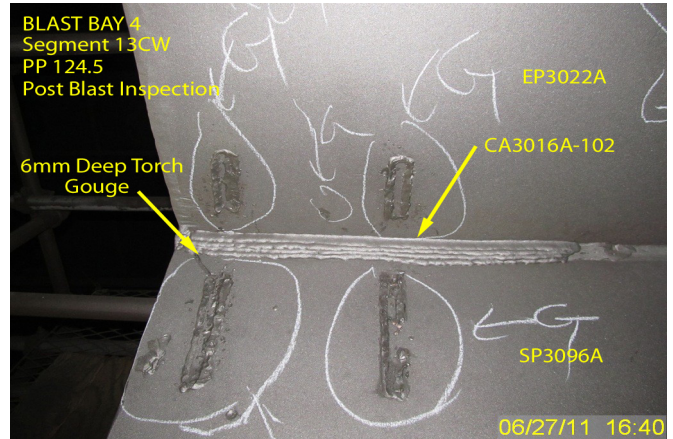
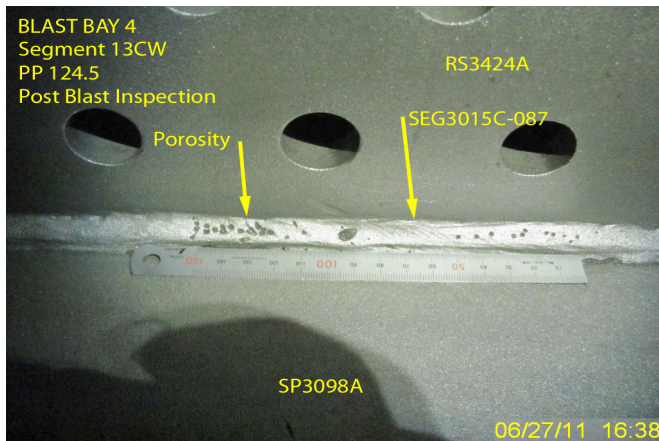
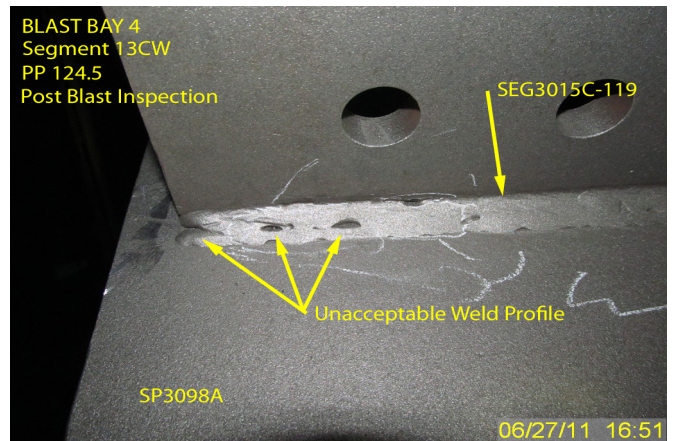
- Piping porosity located in fillet weld SEG3015C-087, PP124.5
- Torch cut gouge in side plate SP3096A near hold back weld CA3016A-102
- Missing weld at edge beam stiffener to floor beam, fillet weld number SEG3015C-153
- Unacceptable weld profile, hold back fillet weld SEG3015C-119
